## Preliminary Arborist Report

**San Francisquito Creek Multi-benefit Project  
Menlo Park, Palo Alto, & East Palo Alto, CA**

**June 15, 2020**

**Revised April 15, 2021**

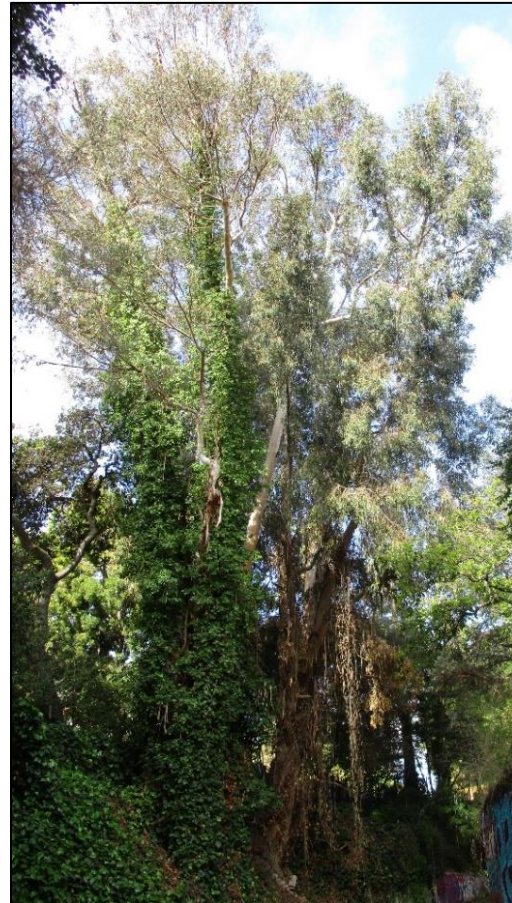
Forty (40) blue gums were assessed. The blue gums were some of the largest trees evaluated with trunk diameters ranging from 12 to 84 inches. The blue gums were in relatively good condition for the size and species. Twenty-one (21) trees were in fair condition, 11 trees were in good condition, and eight were in poor condition. The most notable blue gum was #264 which had a trunk diameter of 84 inches and was in excellent condition. Blue gums were the dominate tree in several areas. A large group was growing north of the Newell Street bridge (Photo 3).

**Photo 3.** Blue gums north of the Newell St. bridge was typical of the blue gums assessed, with tall narrow crowns and ivy engulfing the base, trunk and in some cases, crowns.

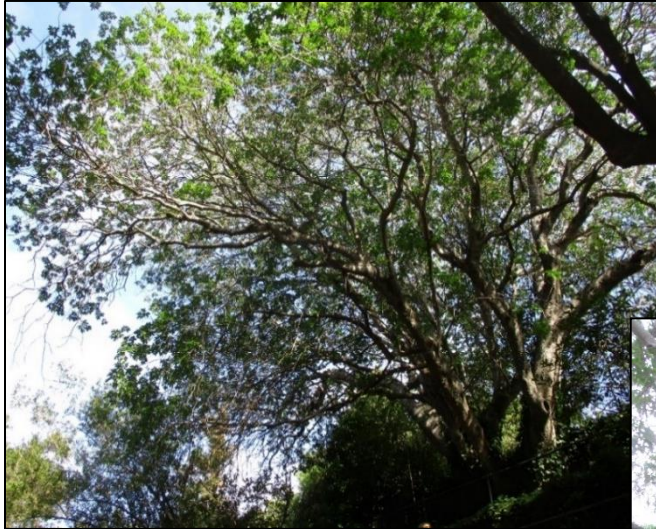
**Photo 4.** California buckeye (tree #167) was in good condition with excellent form.

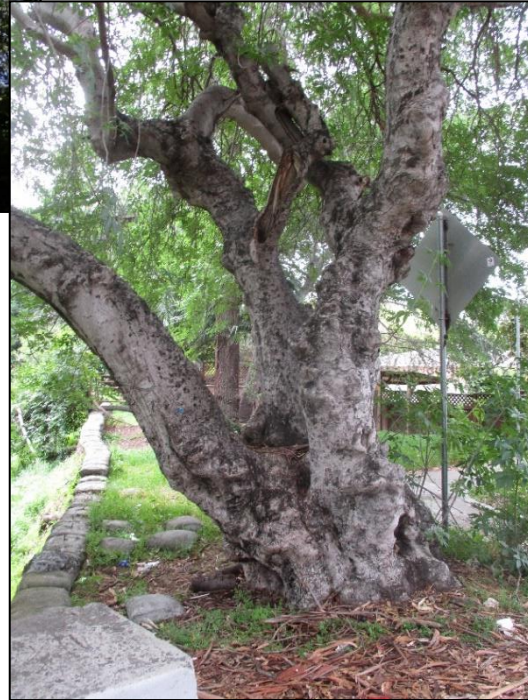
**Photo 5 (below).** California buckeye #295 had a history of branch failure, decay, and cavities. Despite the condition the tree contributed to the character of the neighborhood.

Two buckeye trees were notable: tree #167 and #295. Tree #167 was growing in the pocket park along Woodland Ave. and #295 was growing on the south west corner of the Newell St bridge (Photos 4 and 5). Tree #167 had excellent form and structure, although the crown was slightly thin, with a full wide-spreading crown. Tree #295 was riddled with decay throughout the base and trunk. Given the location, I recommend an advance inspection to evaluate extent of decay and assess structural stability. The form, size, and locations of the tree made it a beloved landmark in the neighborhood.
