Preliminary Arborist Report

**San Francisquito Creek Multi-benefit Project
Menlo Park, Palo Alto, & East Palo Alto, CA**

**June 15, 2020
Revised April 2021**

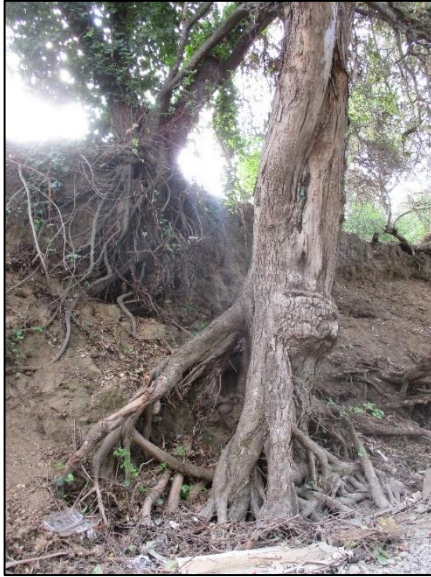
Photo 1 (left). Black acacia #482 had roots exposed by water scouring away the soil.

Trees were growing along the top of the bank, lining the bank into the Creek, and in the Creek channel. At the toe of the bank adjacent to the active channel, soil had eroded leaving the trees with exposed roots (Photo 1, next page).

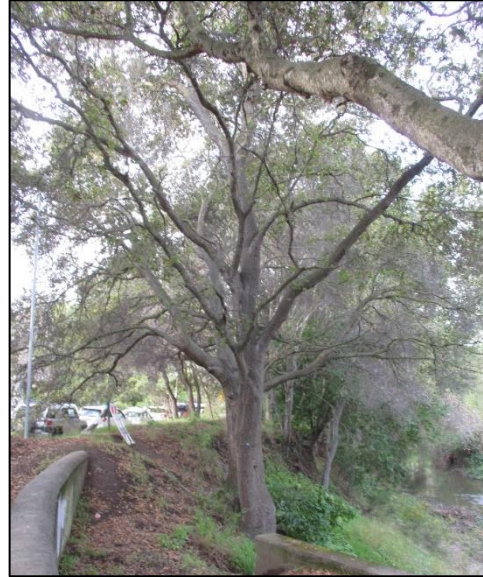
Photo 2. Coast live oak #2 at the top of the slope, at the southwest corner of Pope Chaucer Bridge.

By far the most common tree species was coast live oak with almost half the population (217 trees). One hundred seventeen (116) live oaks were in fair condition, 71 were in good condition, and 30 were in poor condition. The live oaks were semi-mature to mature in development with trunk diameters ranging in size from 4 to 56 inches. The average trunk diameter was 15 inches. Coast live oaks were prevalent at the top of the slopes, often lining roadways or planted in park like settings (Photo 2).

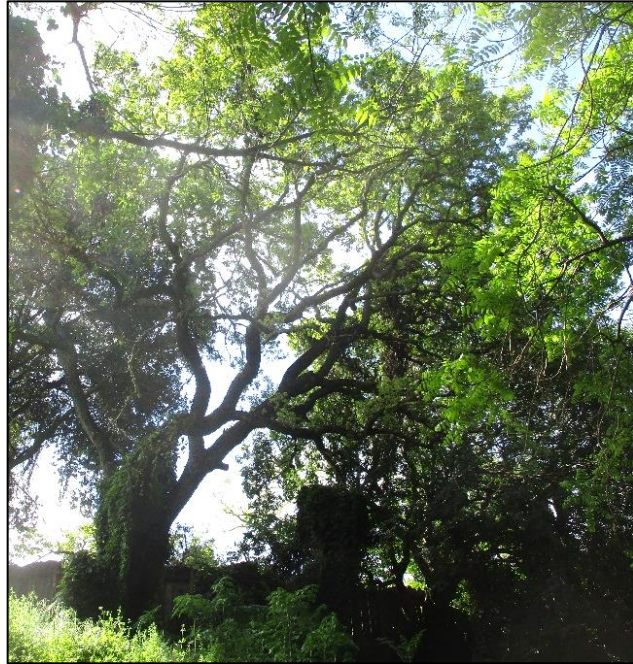
- Valley oak #406 which was in good condition with trunk diameters of 18 and 15 inches and a nice crown (Photo 6).
- Four Southern magnolia street trees were growing in the area of the Pope Chaucer bridge. All four were in good condition with full healthy crowns.
- Fremont cottonwood #442 was a large specimen for the species with trunk diameters of 36, 24, 20-inches. The cottonwood was in fair condition with multiple attachments arising from the base; the 20-inch leaned heavy over creek growing at the bottom of the creek.

Photo 6. Valley oak #406 was growing at the top of the slope and was in good condition.
