Preliminary Arborist Report

**San Francisquito Creek Multi-benefit Project
Menlo Park, Palo Alto, & East Palo Alto, CA**

June 15, 2020

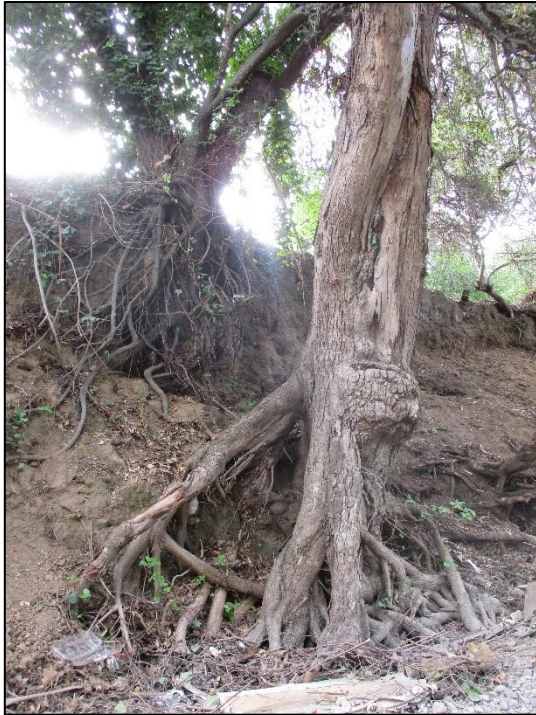
Trees were growing along the top of the bank, lining the bank into the Creek, and in the Creek channel. At the toe of the bank adjacent to the active channel, soil had eroded leaving the trees with exposed roots (Photo 1, next page).

Photo 1. Black acacia #482 had roots exposed by water scouring.

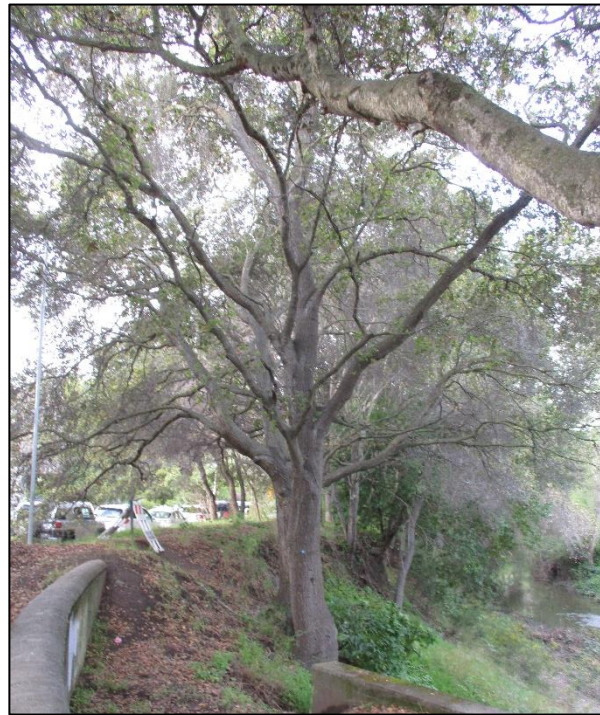
Photo 2. Coast live oak #2 was growing at the top of the slope, close to the southwest corner of the Pope Chaucer Bridge.

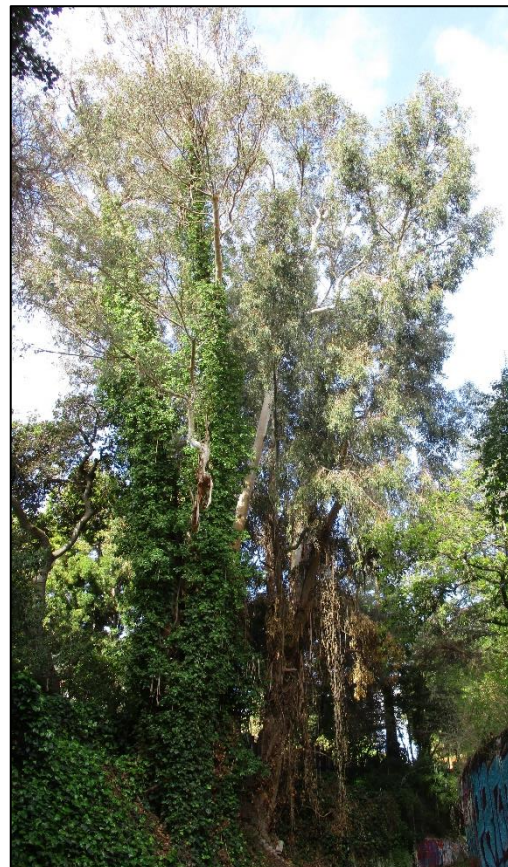
Photo 3. The group of blue gums north of the Newell St. bridge was typical of the blue gums assessed, with tall narrow crowns and ivy engulfing the base, trunk and in some cases, crowns.

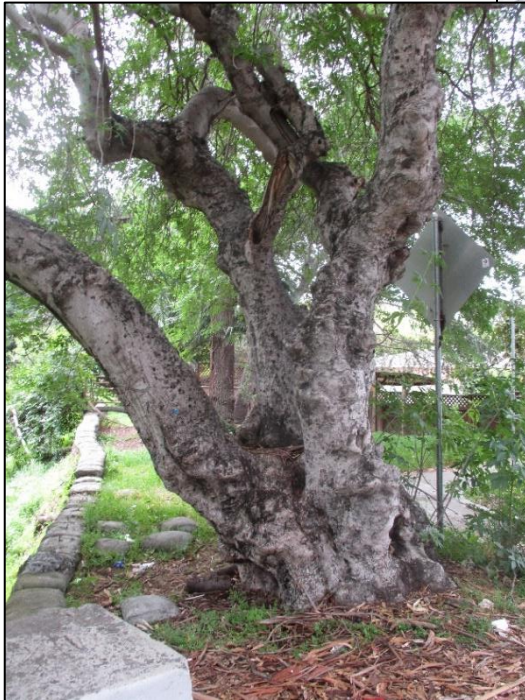
Photo 4. California buckeye (tree #167) was in good condition with excellent form.

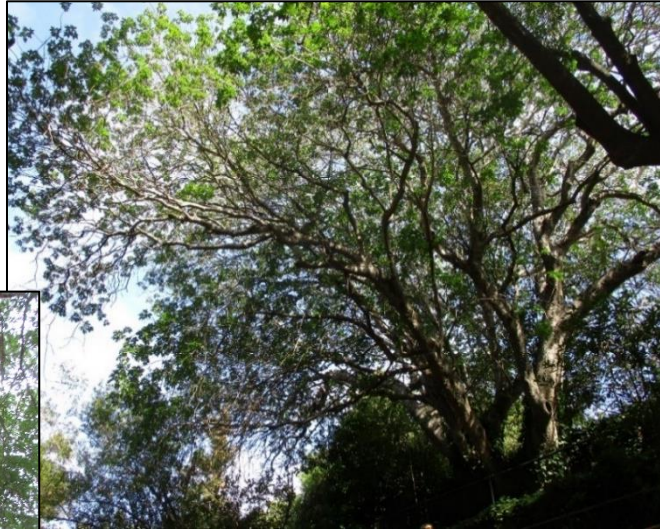
Photo 5 (below). California buckeye #295 had a history of branch failure, decay, and cavities. Despite the condition the tree contributed to the character of the neighborhood.

Tree #167 had excellent form and structure, although the crown was slightly thin, with a full wide-spreading crown. Tree #295 was riddled with decay throughout the base and trunk. Given the

location, I recommend an advance inspection to evaluate extent of decay and assess structural stability. The form, size, and locations of the tree made it a beloved landmark in the neighborhood.
