SAN FRANCISQUITO CREEK  
JOINT POWERS AUTHORITY

## **Agenda Item 4 – Information Item Regarding Valley Water’s Technical Memo on San Francisquito Creek Channel Hydraulics.**

# DRAFT FINAL TECHNICAL MEMORANDUM

**PROJECT:** San Francisquito Creek **DATE:** June 5, 2023  
**SUBJECT:** Existing Conditions Hydraulic Model Update  
Post 2022 New Year's Eve Flood  
**PREPARED:** Jack Xu, PE, CFM

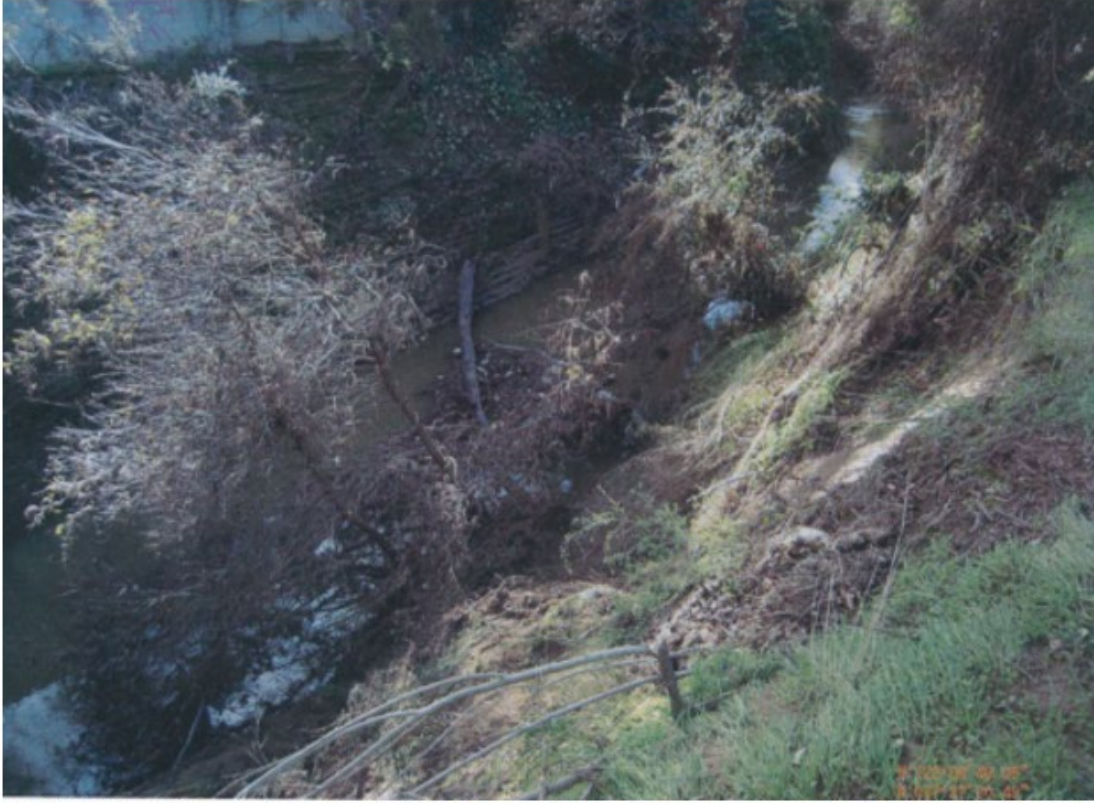
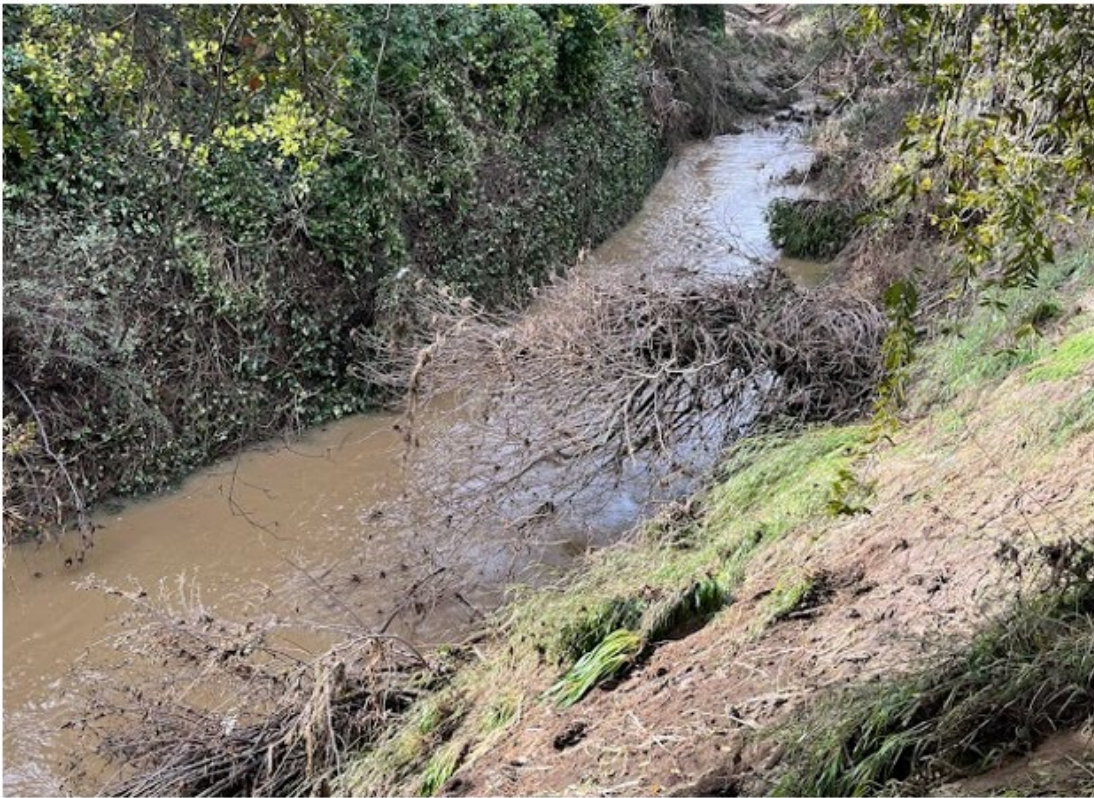
**FIGURE 3:** Post Flood Picture in December 2012 (Top) and December 2022 (Bottom) upstream of University Avenue.

To compare historic conditions, pictures and descriptions from Valley Water's 2012 flood report<sup>6</sup> were used. Older flood reports, such as the one from 1998, do not have quality pictures to compare. Analysis does not show any significant difference in vegetation (Figure 3). In addition, Valley Water maintenance staff perform a creek walk every fall and have not flagged any significant differences in recent memory. The Creek's steep banks and frequent high velocity flows also would inhibit the establishment of long-term vegetation. All this evidence supports the conclusion that vegetation has not changed significantly.

However, the difference in observed floating debris is very stark upstream of Pope Chaucer Bridge. Figure 4 shows significantly more floating debris in the NYE flood event at a peak flow of 5,880cfs versus the 2012 flood event with a peak flow of 5,400cfs (USGS gage at Stanford). However, in the previous Figure 3, the debris remaining on vegetation limbs appear similar.

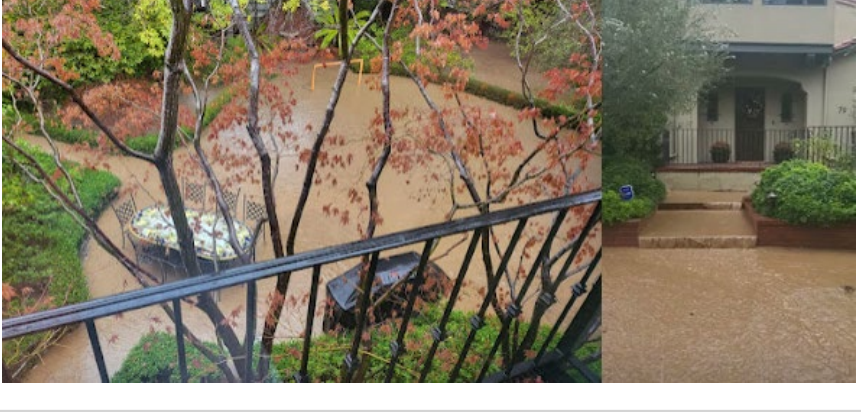
Woodland Avenue near Emma Lane	41' on Roadway	40.5'

**APPENDIX A: Revised Model Water Surface vs. Observed High Water Marks (Photos & LiDAR)**

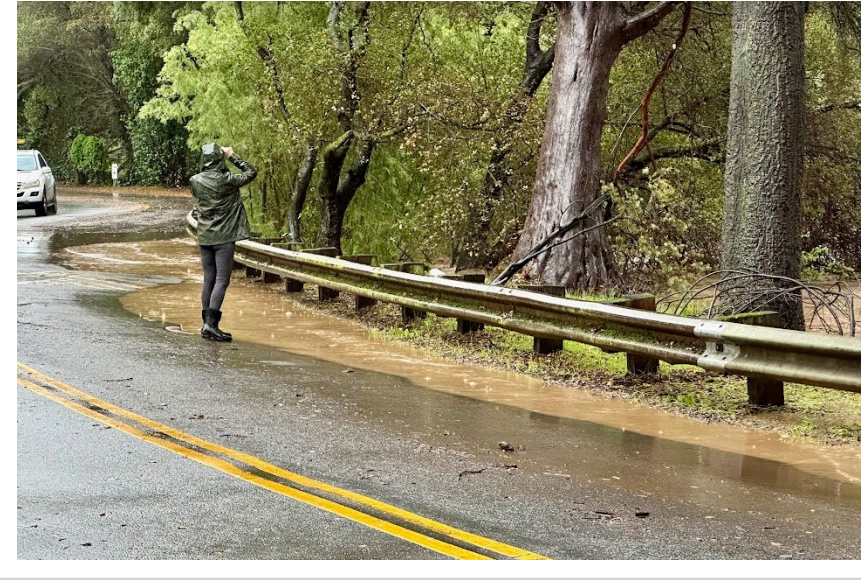
Palo Alto Ave Upstream Pope Chaucer Bridge near the City of Palo Alto Pump	47'	48'

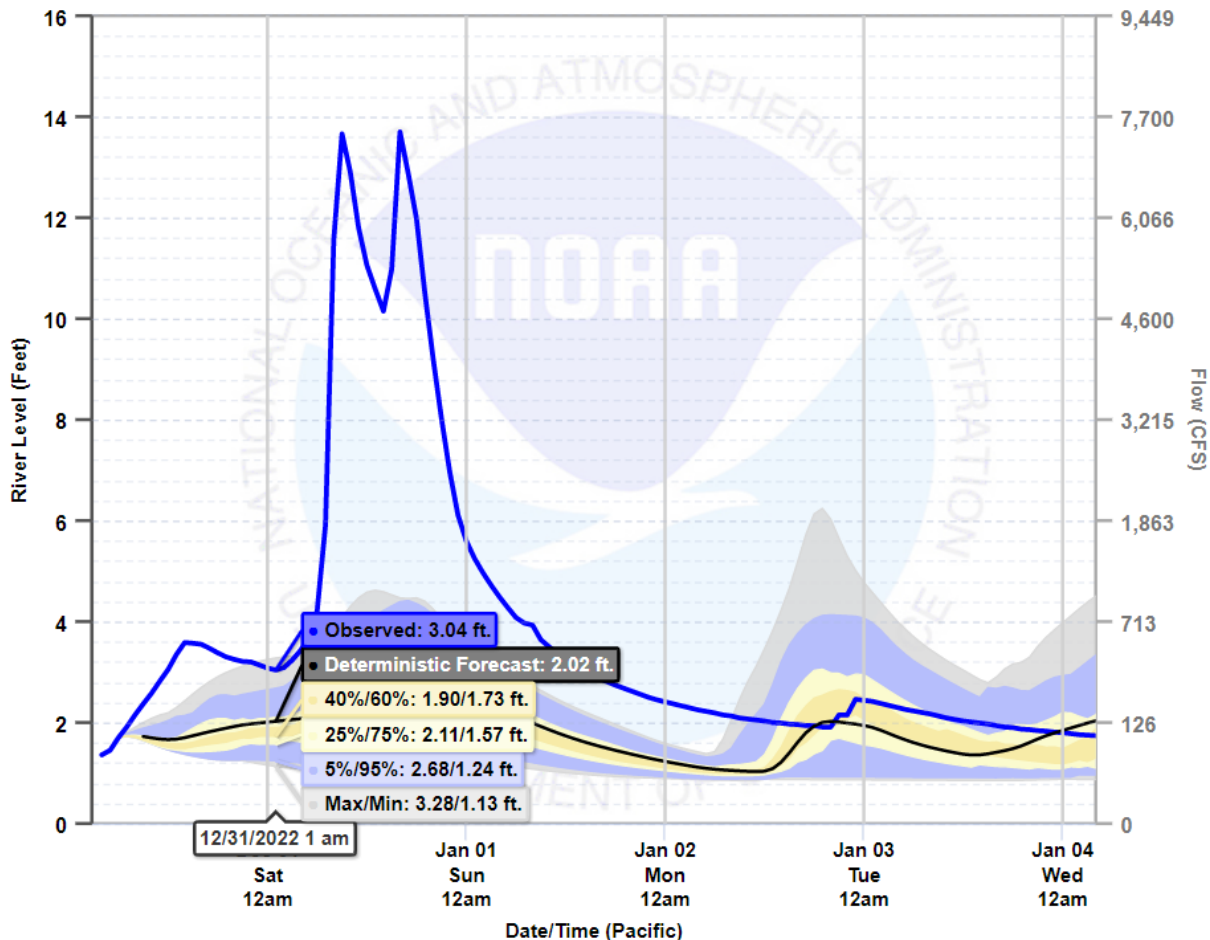
## Hourly River Level Probabilities SAN FRANCISQUITO CREEK - STANFORD UNIVERSITY (SFCC1)

### Chance of River Level Exceedance (Feet)

Forecast Period:  
12/30/2022 4 am - 01/04/2023 4 am
