DRAFT FINAL
TECHNICAL MEMORANDUM

PROJECT: San Francisquito Creek   **DATE**:   June 5, 2023

SUBJECT: Existing Conditions Hydraulic Model Update
Post 2022 New Year's Eve Flood

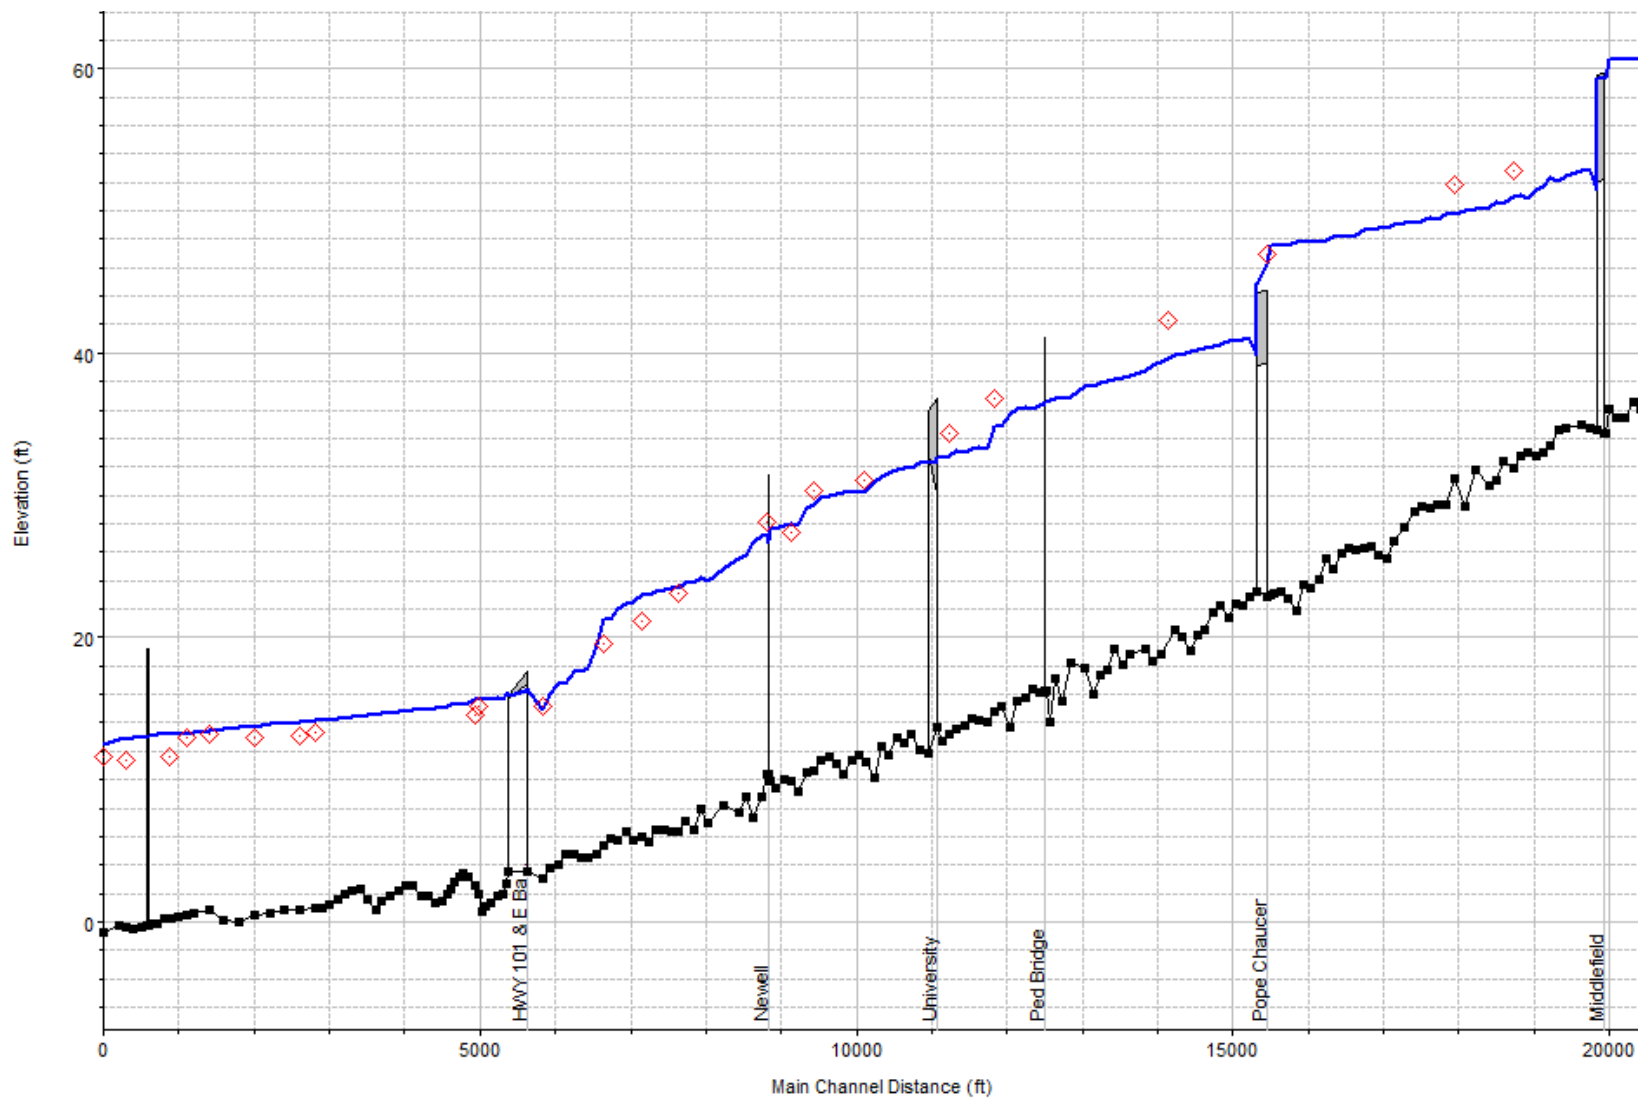
When running the NYE storm event through the 2016 VW Model, Water surface elevations (WSEs) were two feet lower in many locations (Figure 1) when compared to collected High Water Marks (HWMs). Appendix B shows the 2016 VW Model's projected 100yr flooding versus the NYE flooding, which was near a 25yr event. From the data, the model severely underpredicts both the flooding and WSE in areas downstream of Pope Chaucer Street Bridge.

FIGURE 1: 2016 VW Model WSE (Blue) & Observed HWMs (Red) for NYE

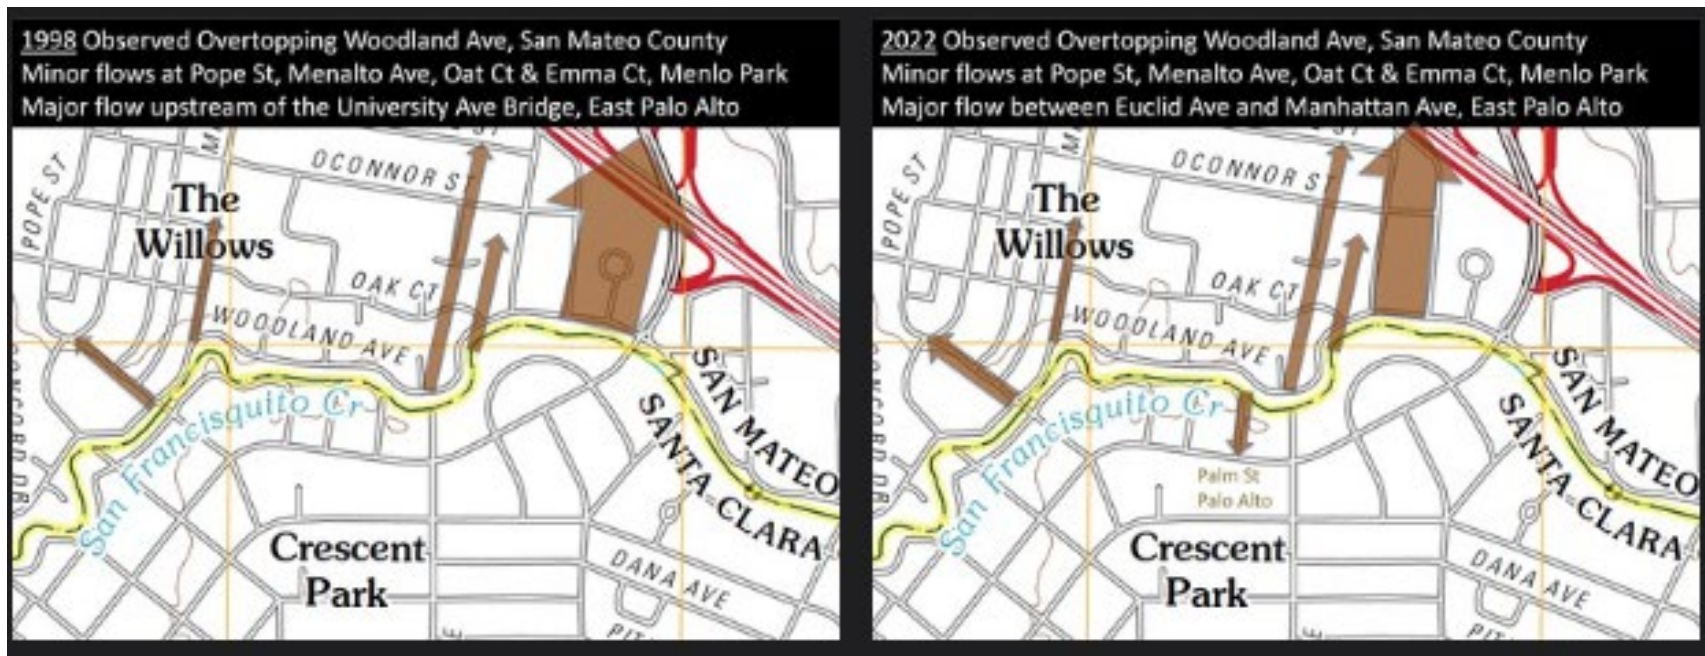
FIGURE 2: Flow Breakout Comparison Between 1998 (left) and 2022 (right). Credit: Jim Wiley, Menlo Park Resident.

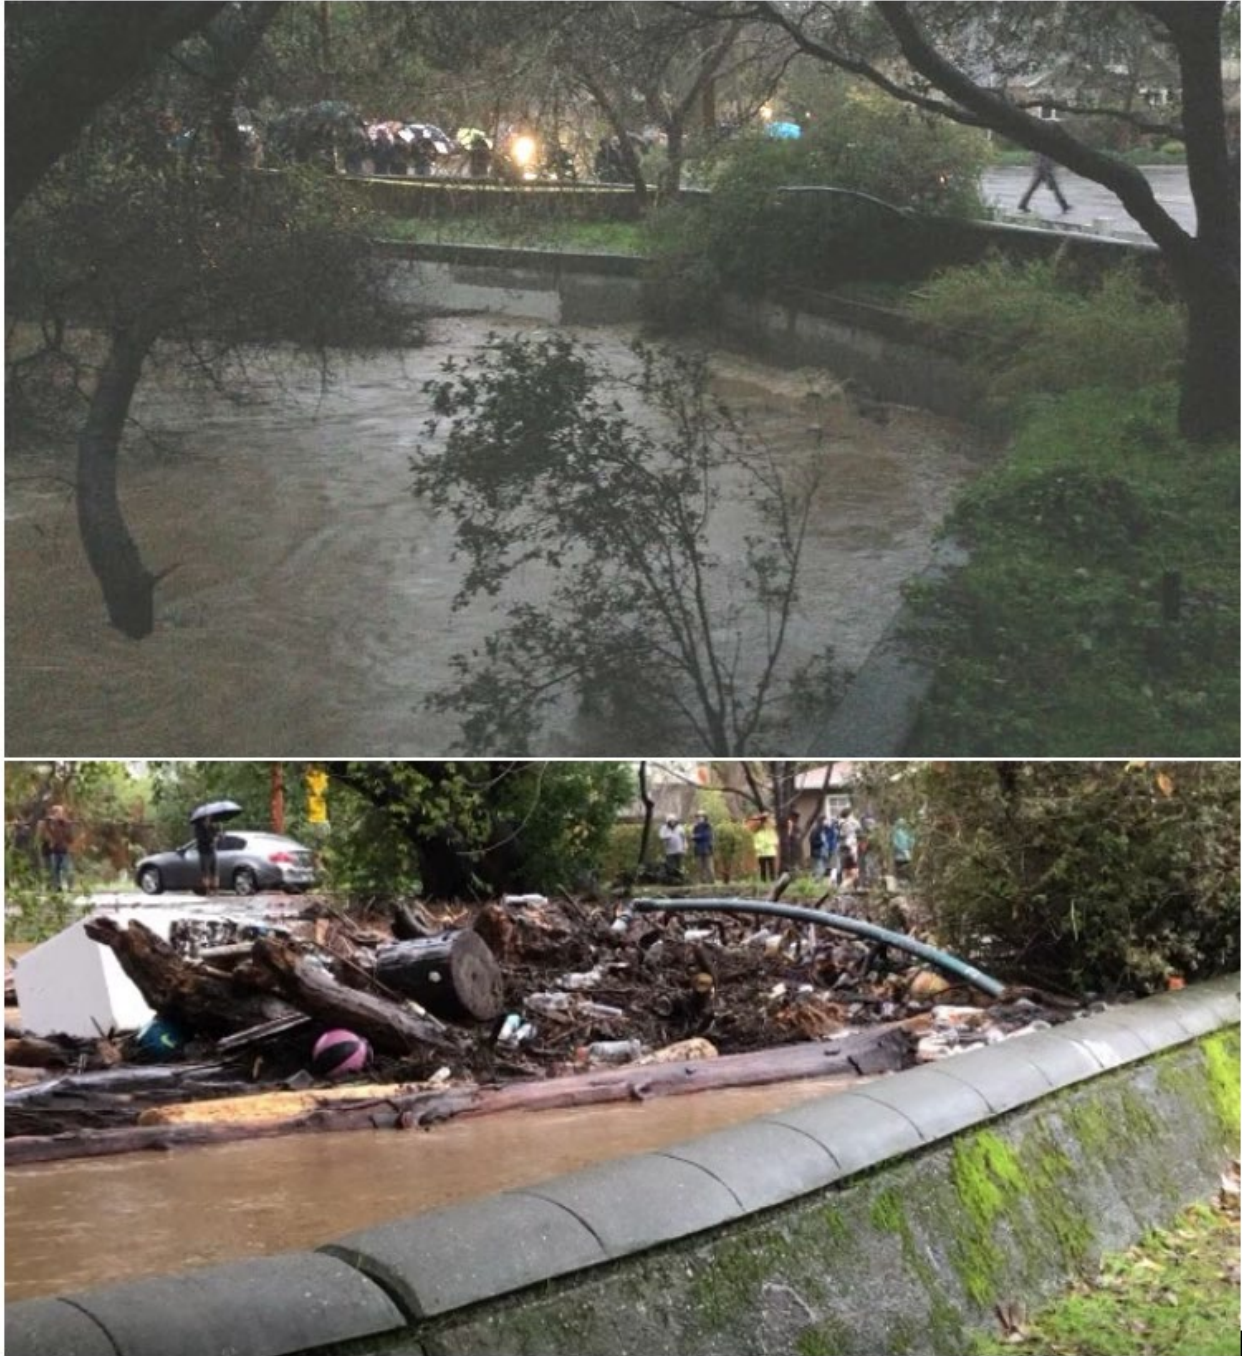
However, the difference in observed floating debris is very stark upstream of Pope Chaucer Bridge. Figure 4 shows significantly more floating debris in the NYE flood event at a peak flow of 5,880cfs versus the 2012 flood event with a peak flow of 5,400cfs (USGS gage at Stanford). However, in the previous Figure 3, the debris remaining on vegetation limbs appear similar.

FIGURE 4: Debris Amount in December 2012 (Top) and December 2022 (Bottom) upstream of Pope Chaucer Bridge

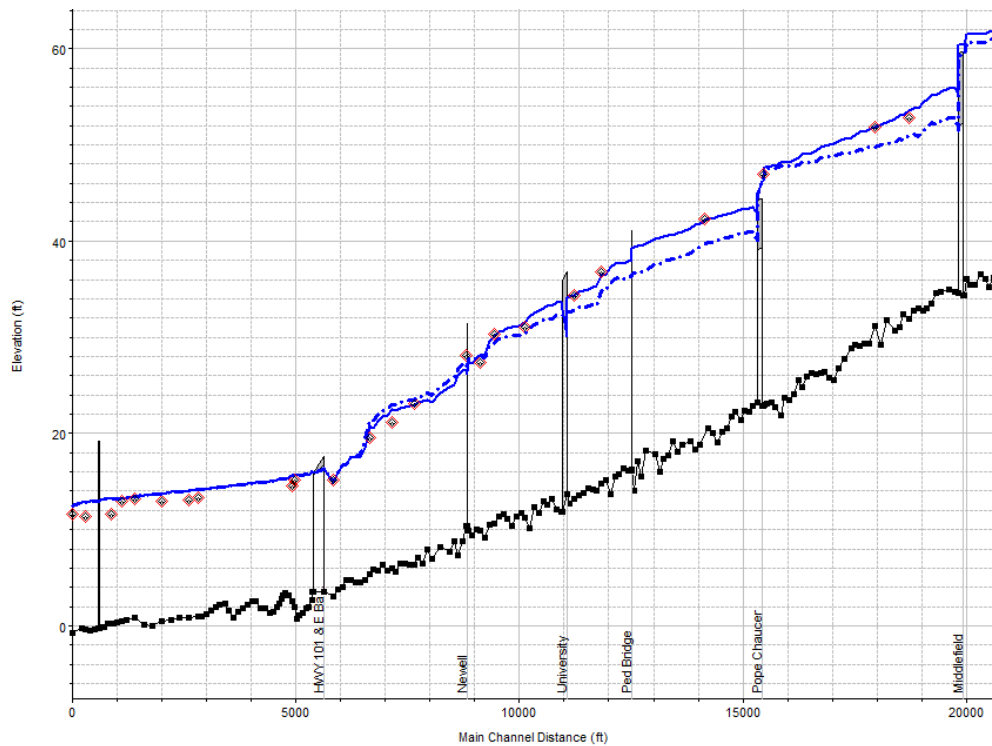
Roughness values were increased from the original roughness coefficient until the WSE generally matched the observed HWMs (Figure 6). This validates the 1D roughness values in the channel. In addition, overbank locations and inundations areas were also compared to validate the 2D model (Figure B-2). Flooding areas and extents generally match. Deviations due to storm drains and physical barriers (property fences and walls) are expected. For example, it is known that on the southern side of the Creek, Palo Alto storm drains mostly flow towards a pump station that was collecting overflow during the NYE storm, reducing the flood footprint. The model corroborated observations that reported little to no flooding during the NYE second peak, which reached 5,430cfs at the USGS gage.

FIGURE 6: Revised Existing Conditions Model (Solid Blue),
2016 VW Model (Dashed Blue) & Observed HWMs (Red) for NYE

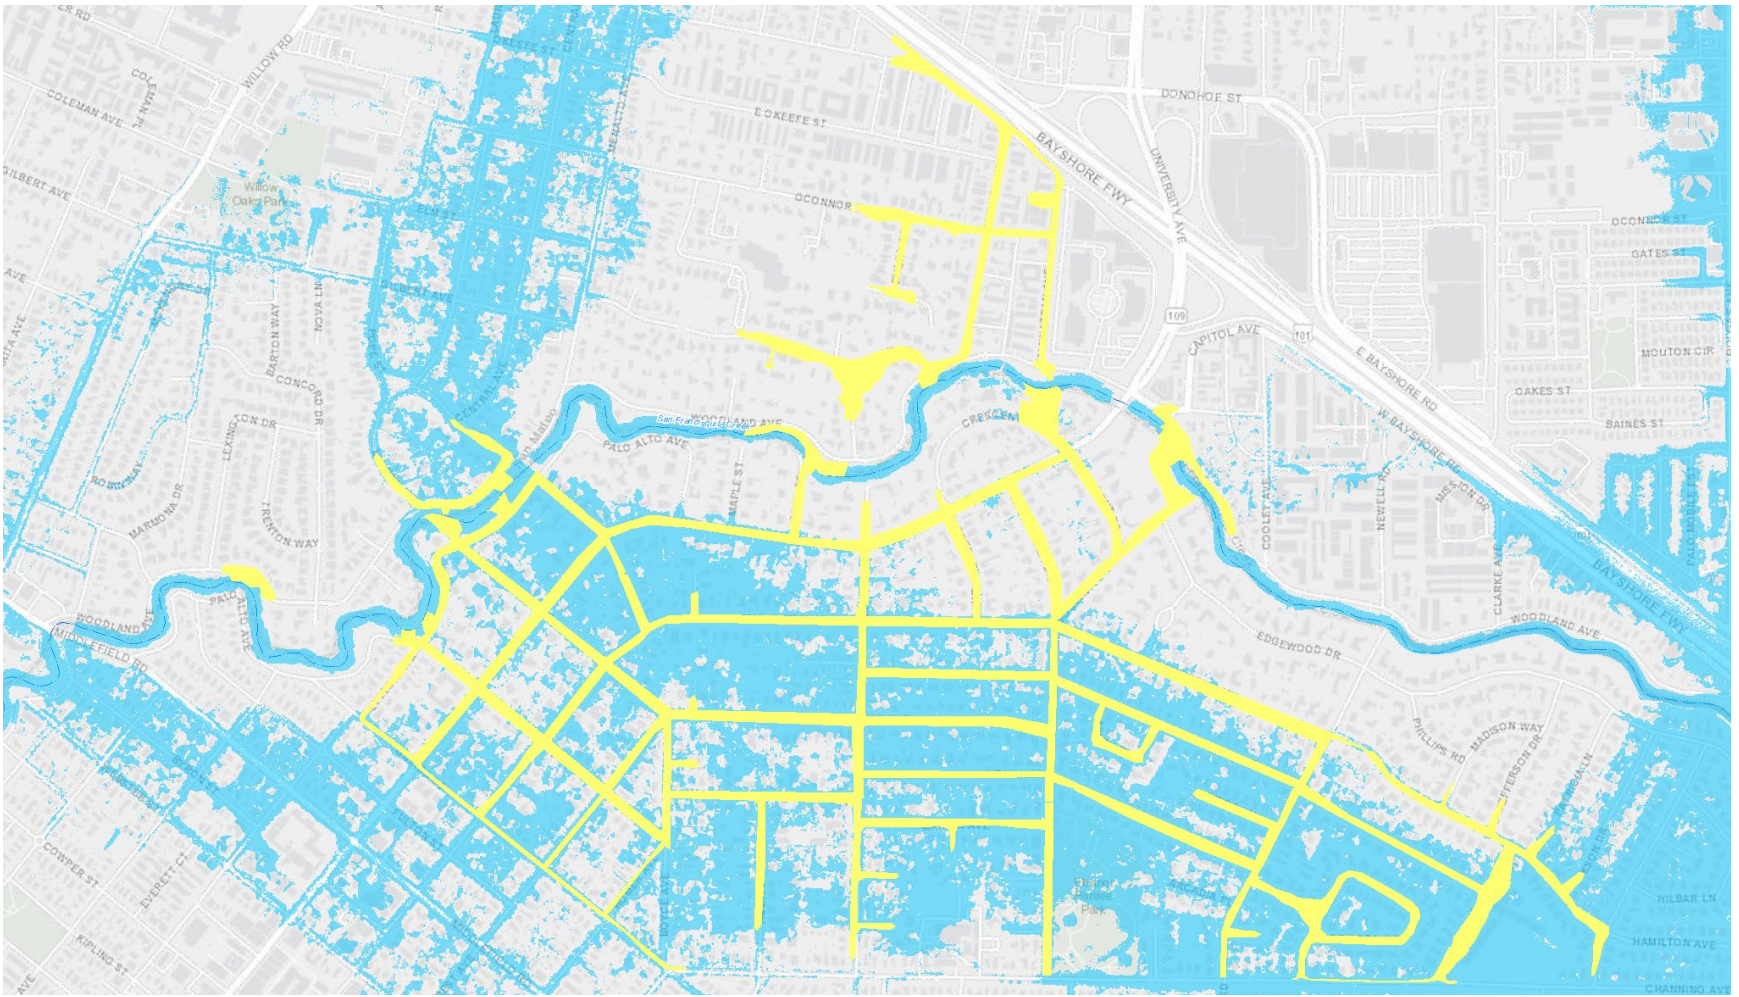
FIGURE B-1: 100yr 2016 VW Model Flooding (Blue), NYE Flooding (Yellow)

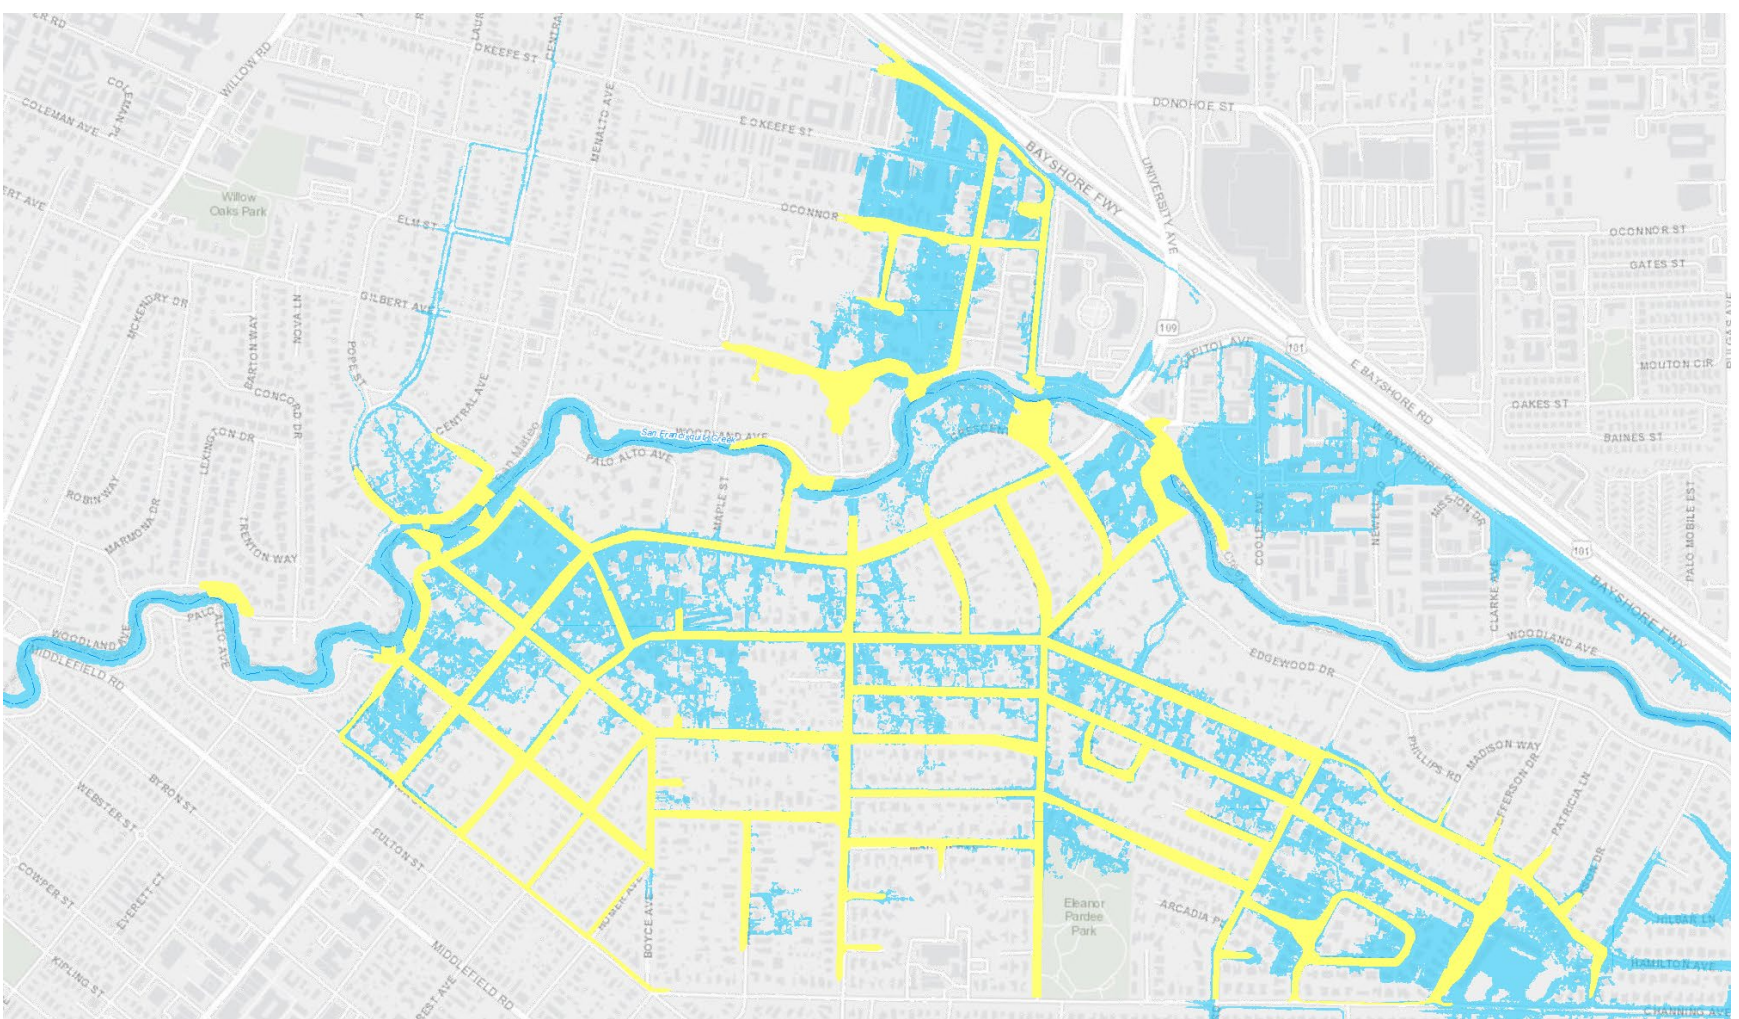
FIGURE B-2: Revised Model NYE Flooding (Blue), NYE Approximate Observed Flooding (Yellow)
