Preliminary Arborist Report

**San Francisquito Creek Multi-benefit Project
Menlo Park, Palo Alto, & East Palo Alto, CA**

**June 15, 2020
Revised April 2021**

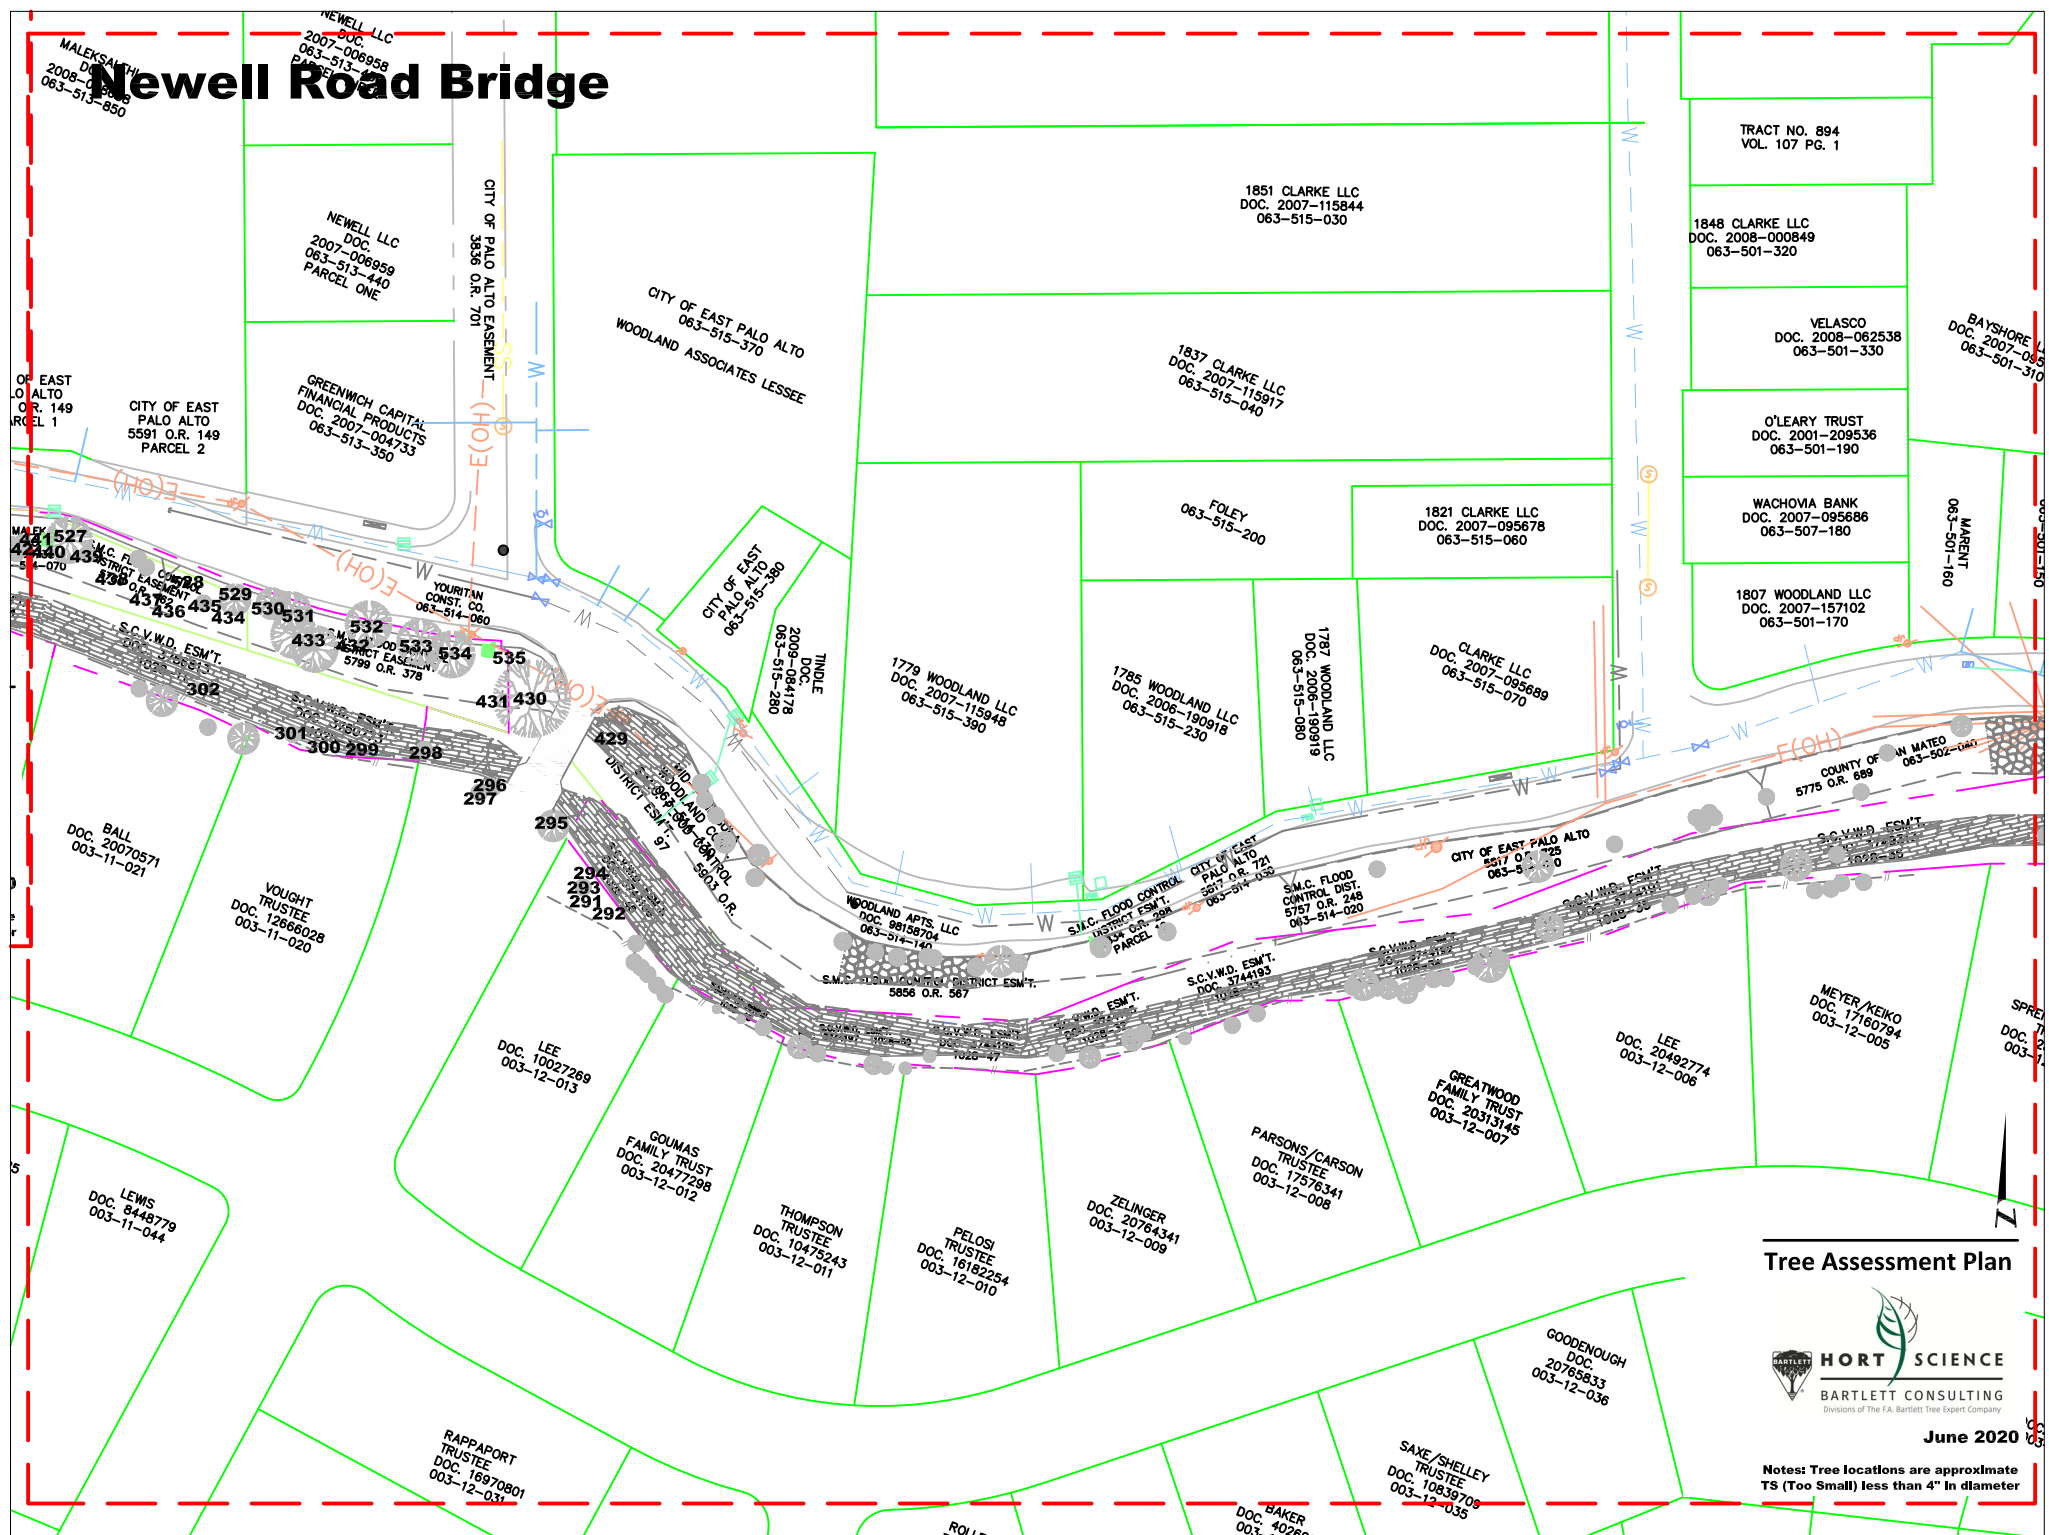
Newell Road Bridge

Forty (40) blue gums were assessed. The blue gums were some of the largest trees evaluated with trunk diameters ranging from 12 to 84 inches. The blue gums were in relatively good condition for the size and species. Twenty-one (21) trees were in fair condition, 11 trees were in good condition, and eight were in poor condition. The most notable blue gum was #264 which had a trunk diameter of 84 inches and was in excellent condition. Blue gums were the dominate tree in several areas. A large group was growing north of the Newell Street bridge (Photo 3).
